**ATLANTIC DIVISION
NAVAL FACILITIES ENGINEERING COMMAND
NORFOLK, VA**

AIRFIELD PAVEMENT CONDITION (PCI) SURVEY

NAS KEFLAVIK, ICELAND

JULY 2001

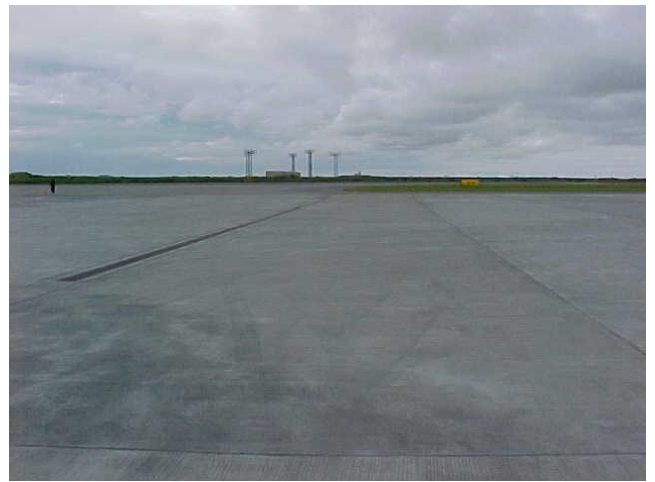
Section CTA-1 is a newly constructed PCC apron surround the new terminal extension. This apron receives the majority of the international, commercial passenger traffic. This area is in excellent condition. However, the joints have not been widened and sealed and are beginning to spall (See Figure 3). It is recommended that the joints be widened and sealed as soon as possible to prevent any further spalling and potential for producing FOD. The strip drain in this area is suspected to be non-airfield rated due to the cracking of the grate, as seen in Figure 1, at the supports. This should be investigated immediately and replaced if found to be inadequate to handle large aircraft wheel loads.

Figure 4. CTA-1 looking south.

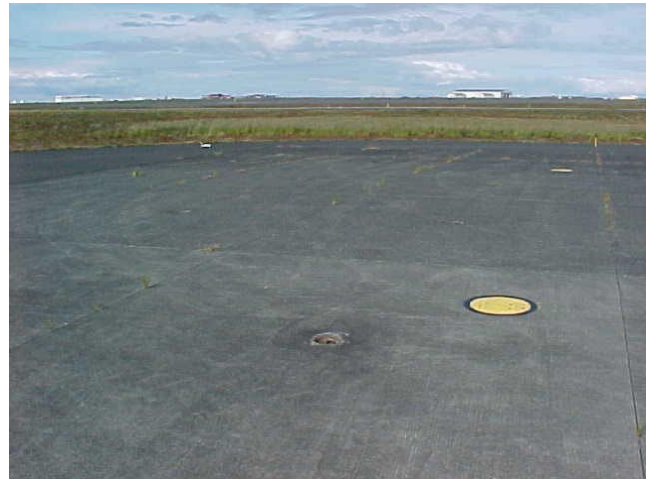
Figure 10. Taxiway D hardstand.

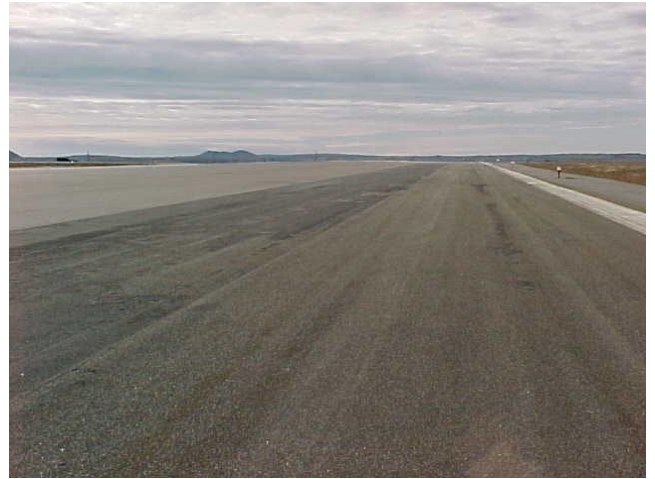
Sections R2-1A and 2A are in very good condition with a mean PCI of 87. These areas are heavily patched. The patches are constructed well and are in good condition. The striping in these areas is obliterated from age and patching. Sections R2-1B and 2B are micro surfaced with Ralumac. These sections are in good to fair condition with an average PCI of 63. As seen in Figure 19, the Ralumac in these areas is extremely weathered and delaminating from the asphalt surface. It is expected the Ralumac will produce a FOD hazard during snowplow operations this winter. The snowplows will most likely remove any of the loose Ralumac during the winter months. However, sweeping operations should be performed with increased vigilance during the summer months until an overlay can be accomplished in these areas.

Figure 20. West sideline of Runway 02-20.
